A CULTURAL RESOURCES ASSESSMENT
OF SELECTED MAGNETIC ANOMALIES
FREEPORT HARBOR, TEXAS
45-FOOT PROJECT

A report submitted to the U.S. Army Corps of Engineers,
Galveston District, by the Texas A&M Cultural Resources
Laboratory in partial fulfillment of Purchase Order
Number DACW64-80-M-0869.

November, 1980

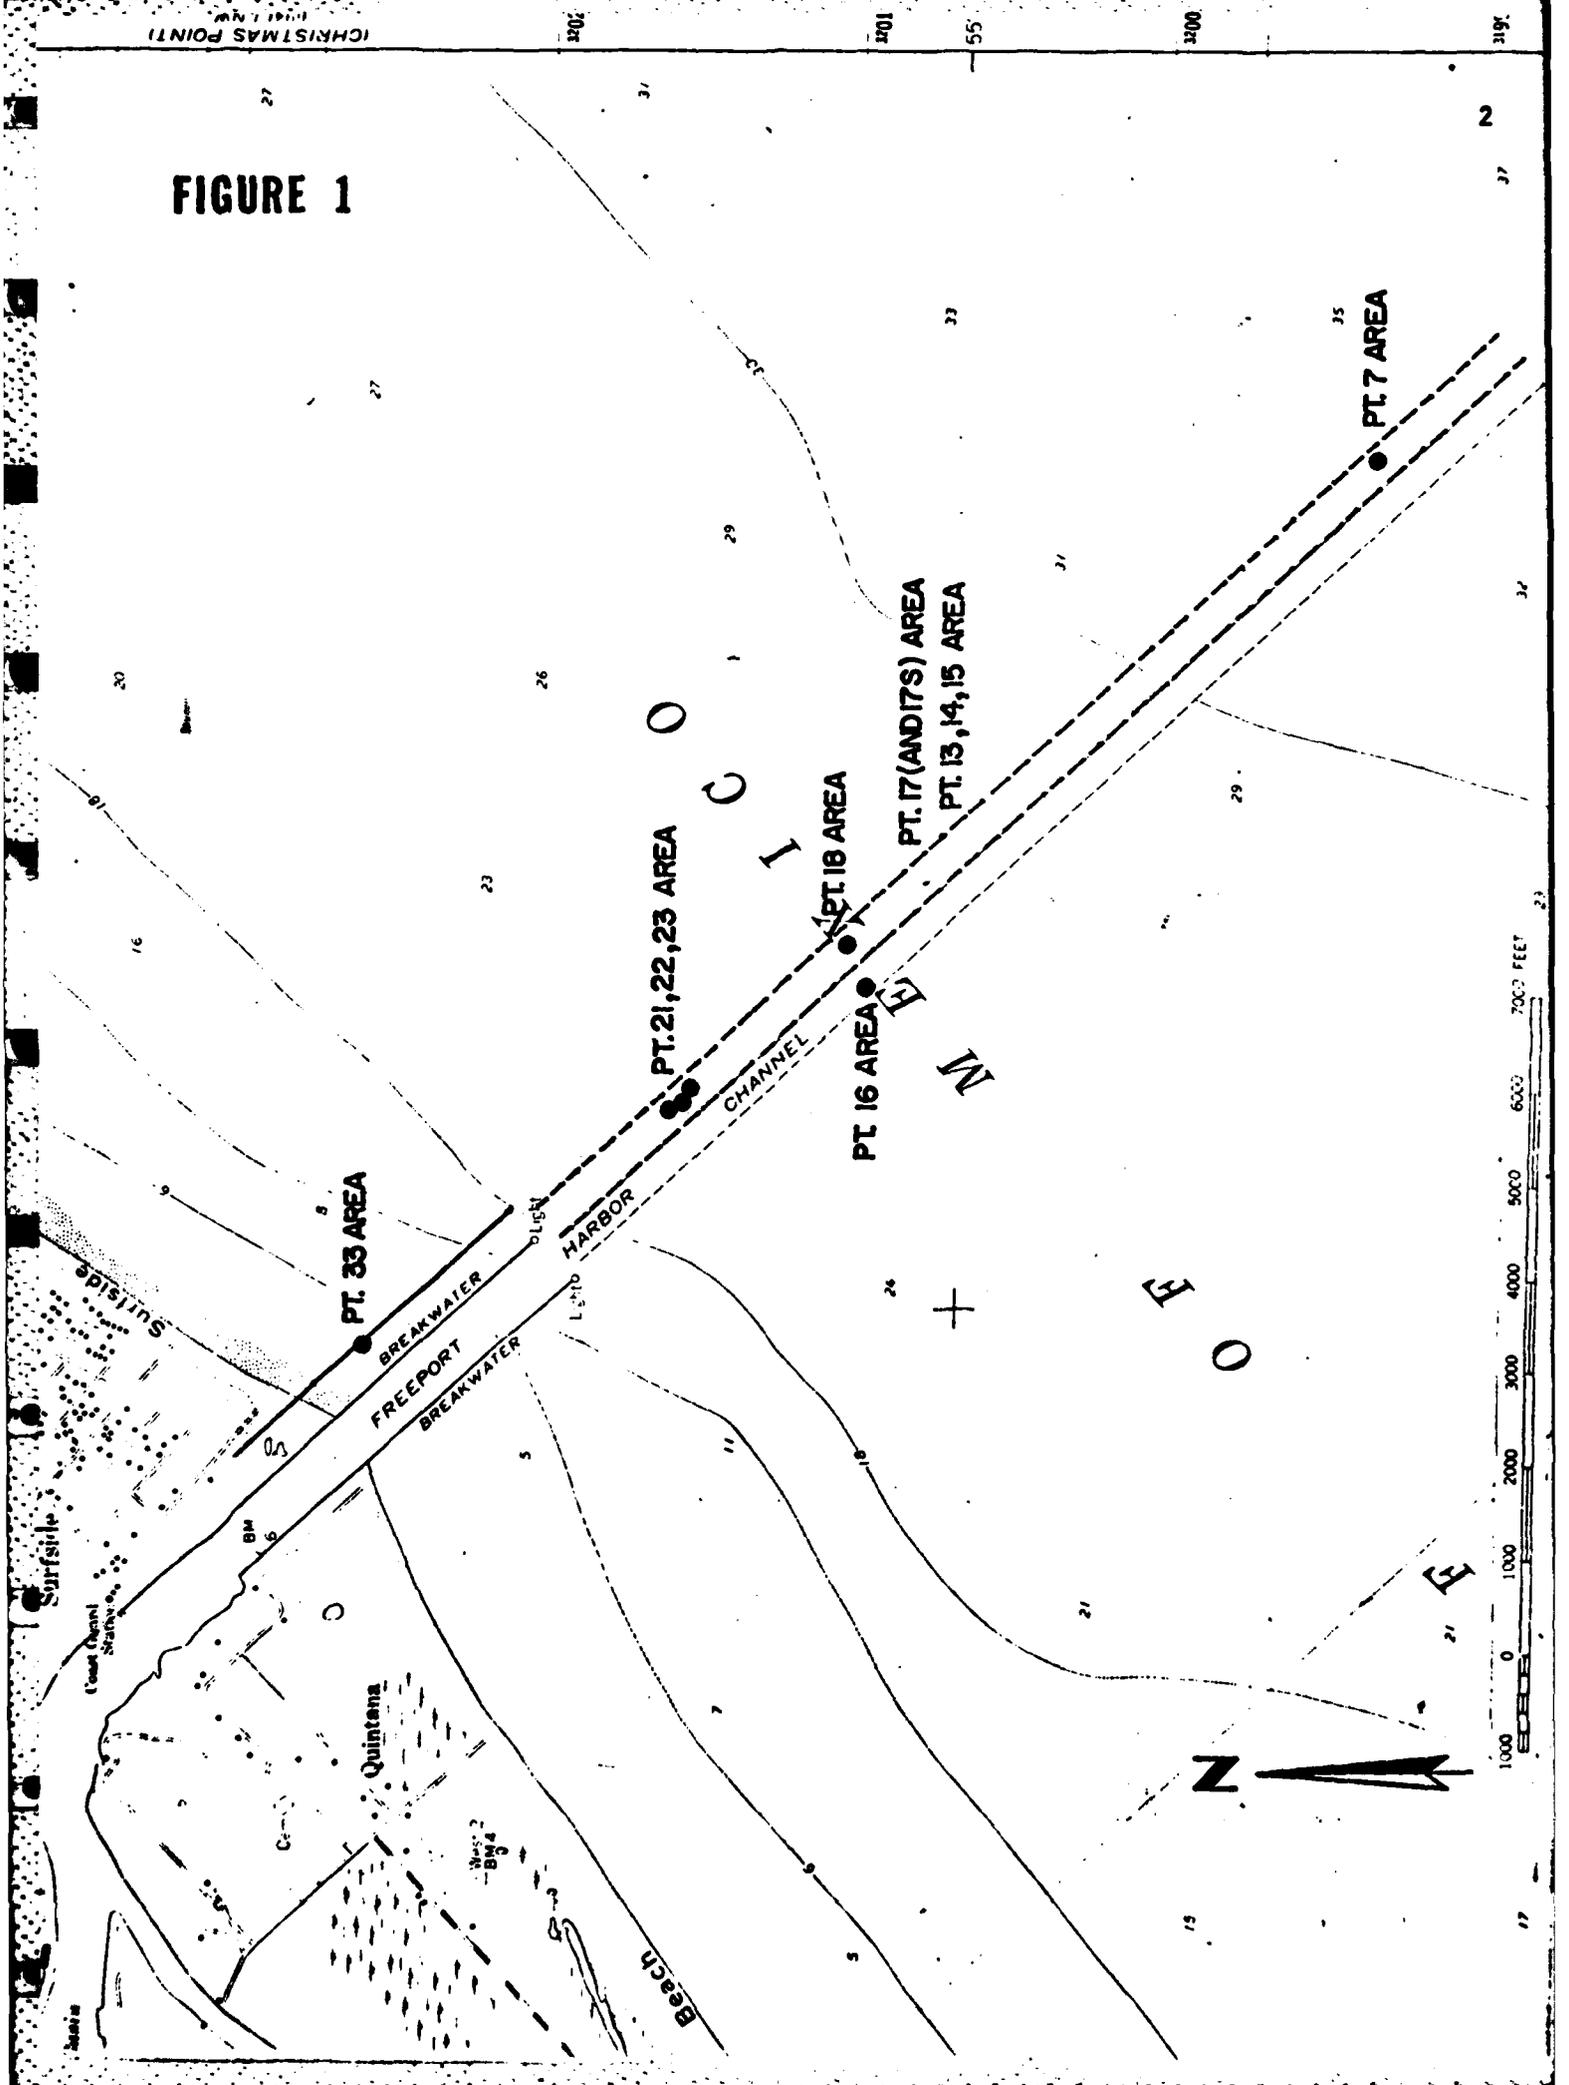
FIGURE 1

A list of the seven Freeport Channel anomaly clusters selected for inspection is presented below, and their positions are illustrated in Figure 1. The interpretations were directly abstracted from the Fairfield (1979:44) report and do not necessarily reflect the opinions of the Texas A&M investigators. The point designations of this report were provided by the Corps of Engineers and do not exactly duplicate the Fairfield (1979) designations. For specific anomalous numbers and gamma counts of individual anomalies the reader is referred to Appendix III of the Fairfield (1979) report.
